Case Study

SIGNAL GANTRY, BROUGH

Client: Network Rail

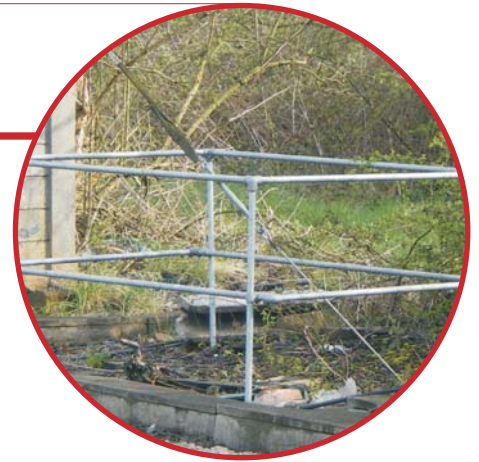
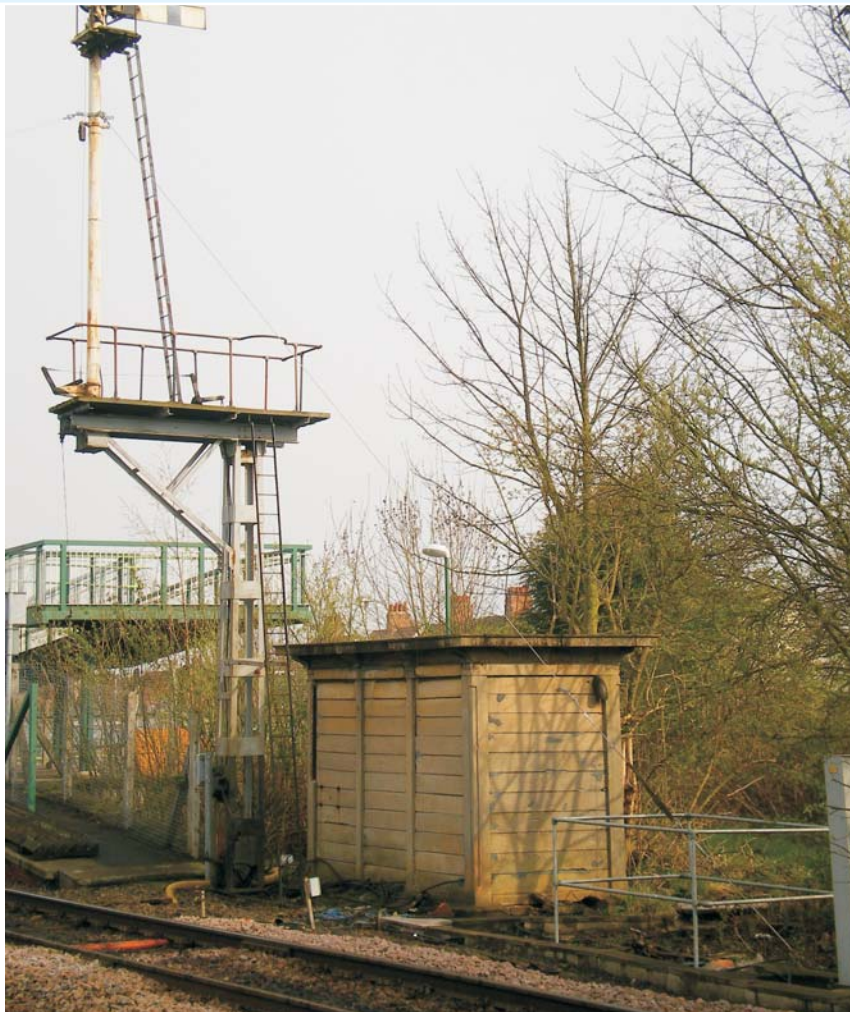
The buffeting effect of high speed wind created by the passing trains was causing increased fatigue to this cantilevered ironwork structure. Without remedial work to prevent this excited oscillation there was a real fear that the signal could in time collapse.

Guy wires were fitted to a collar high up the structure and while two of these were then secured to the steelwork of the adjacent pedestrian bridge the third was attached to a Platipus® anchor driven into the ground alongside the tracks. The stainless steel wire tendon was tightly secured to the collar and also to a stainless steel turnbuckle arrangement to allow proper tensioning of the system. The anchor itself was installed within a matter of minutes using simple hand held equipment.

Anchor System: B06TC spheroidal graphite cast iron anchor c/w 4m of 12mm Ø stainless steel wire tendon, terminating with a hard eye and stainless steel turnbuckle.
