# Case Study

## WEST WICKHAM CUTTING, KENT

**Client:** Network Rail

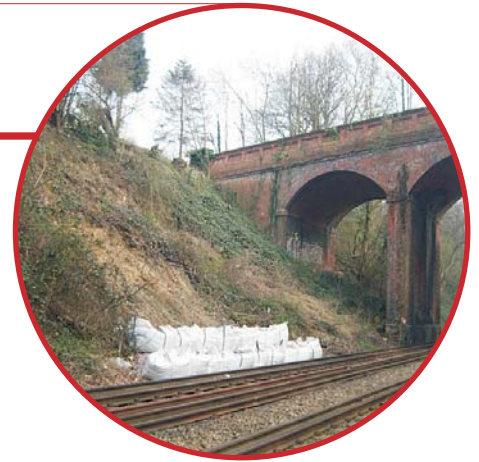
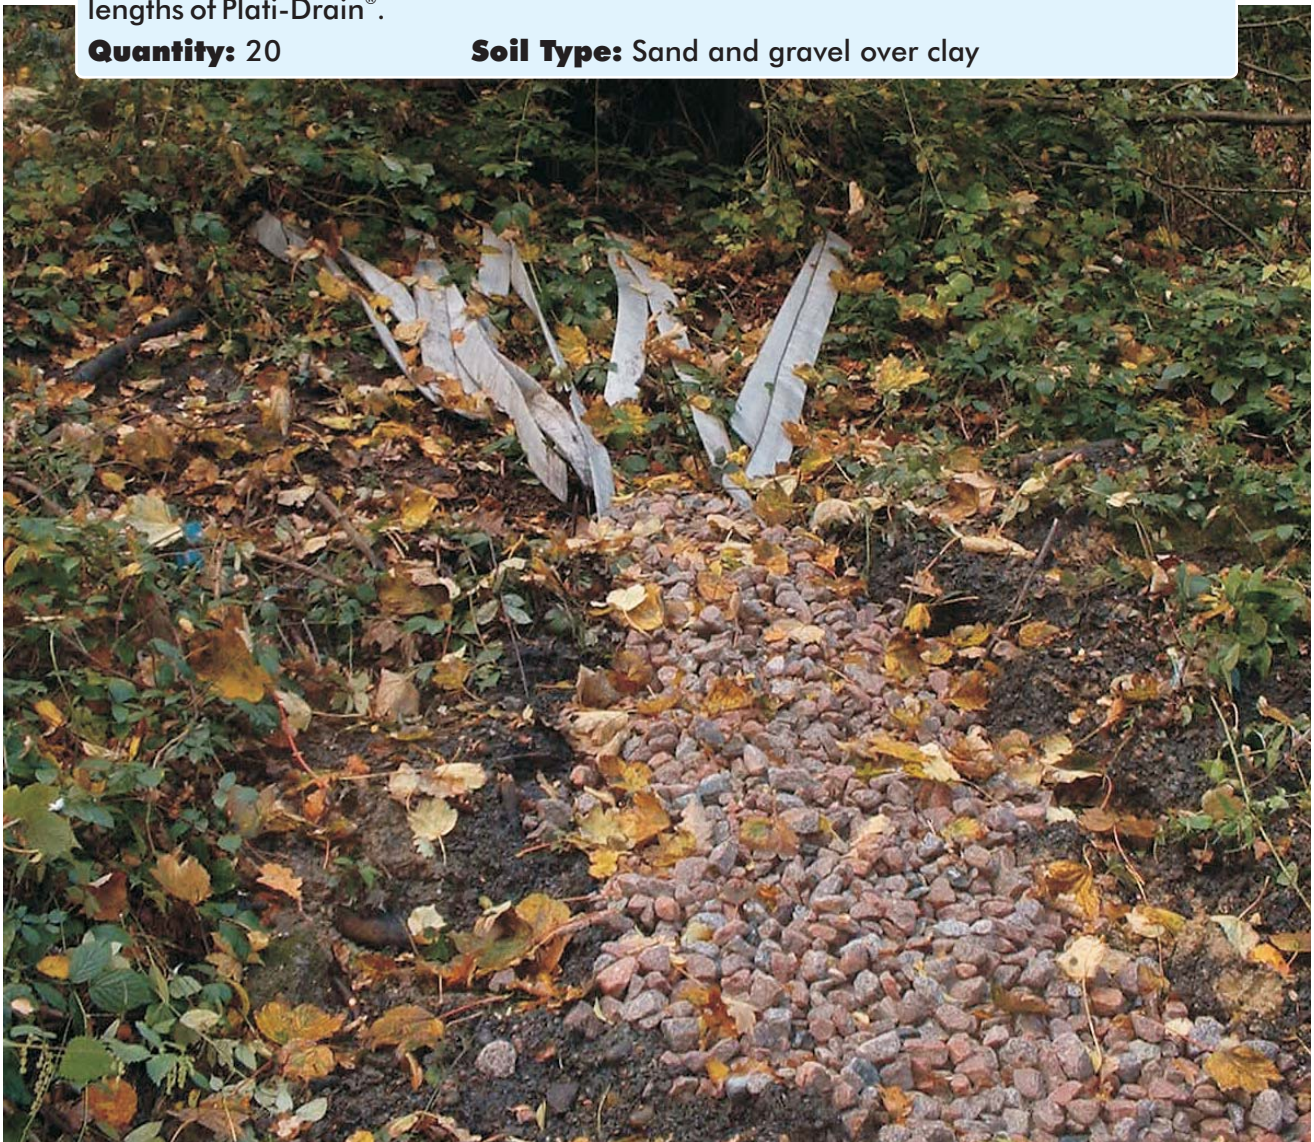
9m double lengths of Plati-Drain<sup>®</sup> were introduced into the slope using a B06 anchor head. These were installed in a series of fan like patterns, with the tails of the Plati-Drain<sup>®</sup> taken to a counterfort drain to allow the water to be safely taken to the foot of the slope. Installation was achieved during an overnight possession using a road-railer fitted with a hydraulic pecker.

**Anchor System:** B06TC galvanised spheroidal graphite iron anchor c/w 9m double lengths of Plati-Drain<sup>®</sup>.
