Case Study

GREASBOROUGH DYKE - ROTHERHAM

Client: Henry Boot Ltd

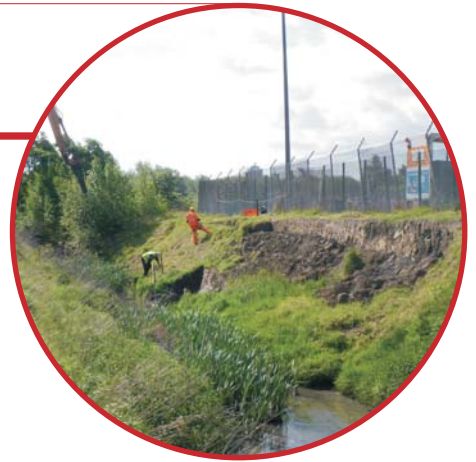
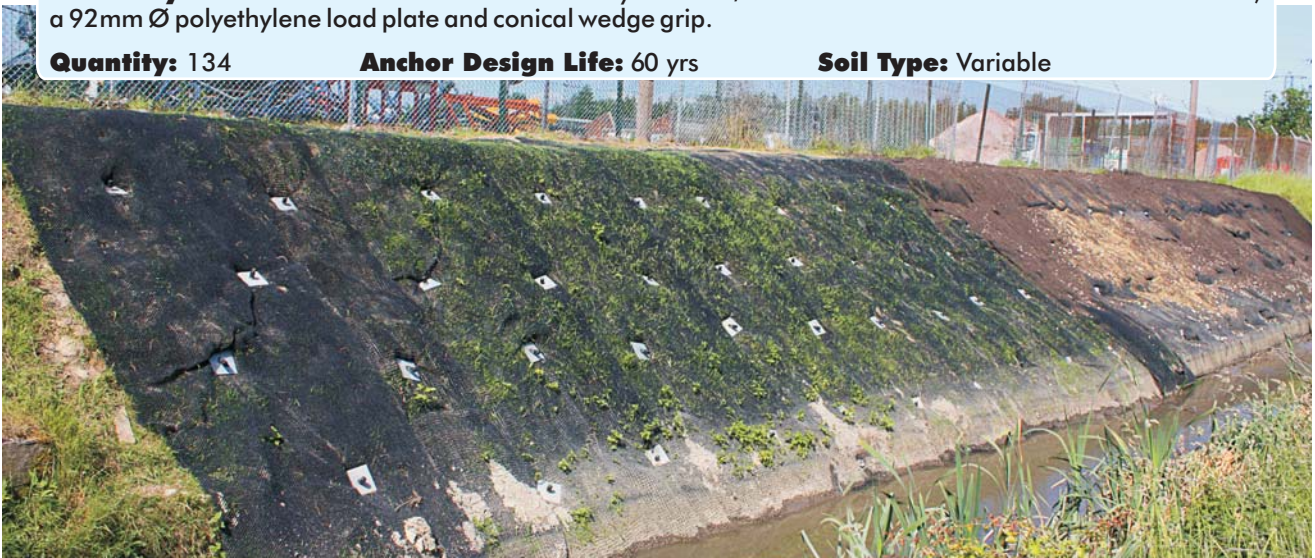
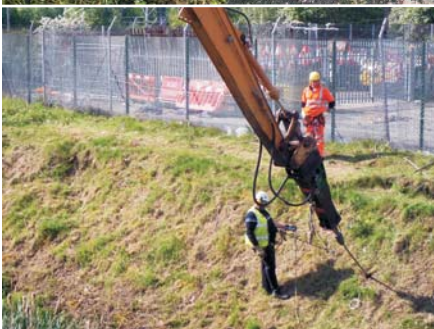
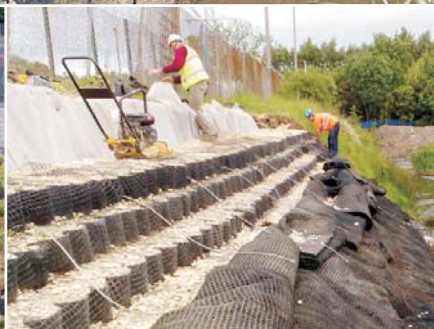
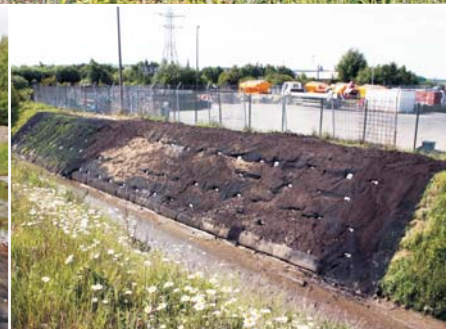
Steep embankments to this drainage dyke formed a boundary for a council depot and development site. Rapidly rising and falling water levels on top of surface water caused a large section of this bank to fail. The resulting slip partially blocked the water channel leading to a rise in water levels and seriously undermined the boundary. Remedial work to rebuild and stabilise the slope with minimum disruption was required.

The section of failed slope was removed to allow the installation of a cellular confinement system. The new structure was filled with a granular mix and rebuilt with an incline to match the existing embankment. Anchors were installed on a grid pattern through this filled cellular system as well as across the affected slope to provide long term stability. To minimise any future pore water pressure build up, a series of 'Active' Plati-Drain® anchors were also installed. Load plates were used on all anchors to secure the Tencate 2020/20 geogrid and stabilise the surface to help retain the topsoil and aid re-vegetation. A row of Geo System anchors were used at the crest and toe of the slope to help tightly profile the geogrid product.
