Case Study

STONER HILL, STEEP, NR PETERSFIELD

Client: Hampshire County Council
Consultant: Dean and Dyball Construction Ltd
Contractor & Anchor Installer: [Precision Cutting Ltd](#)

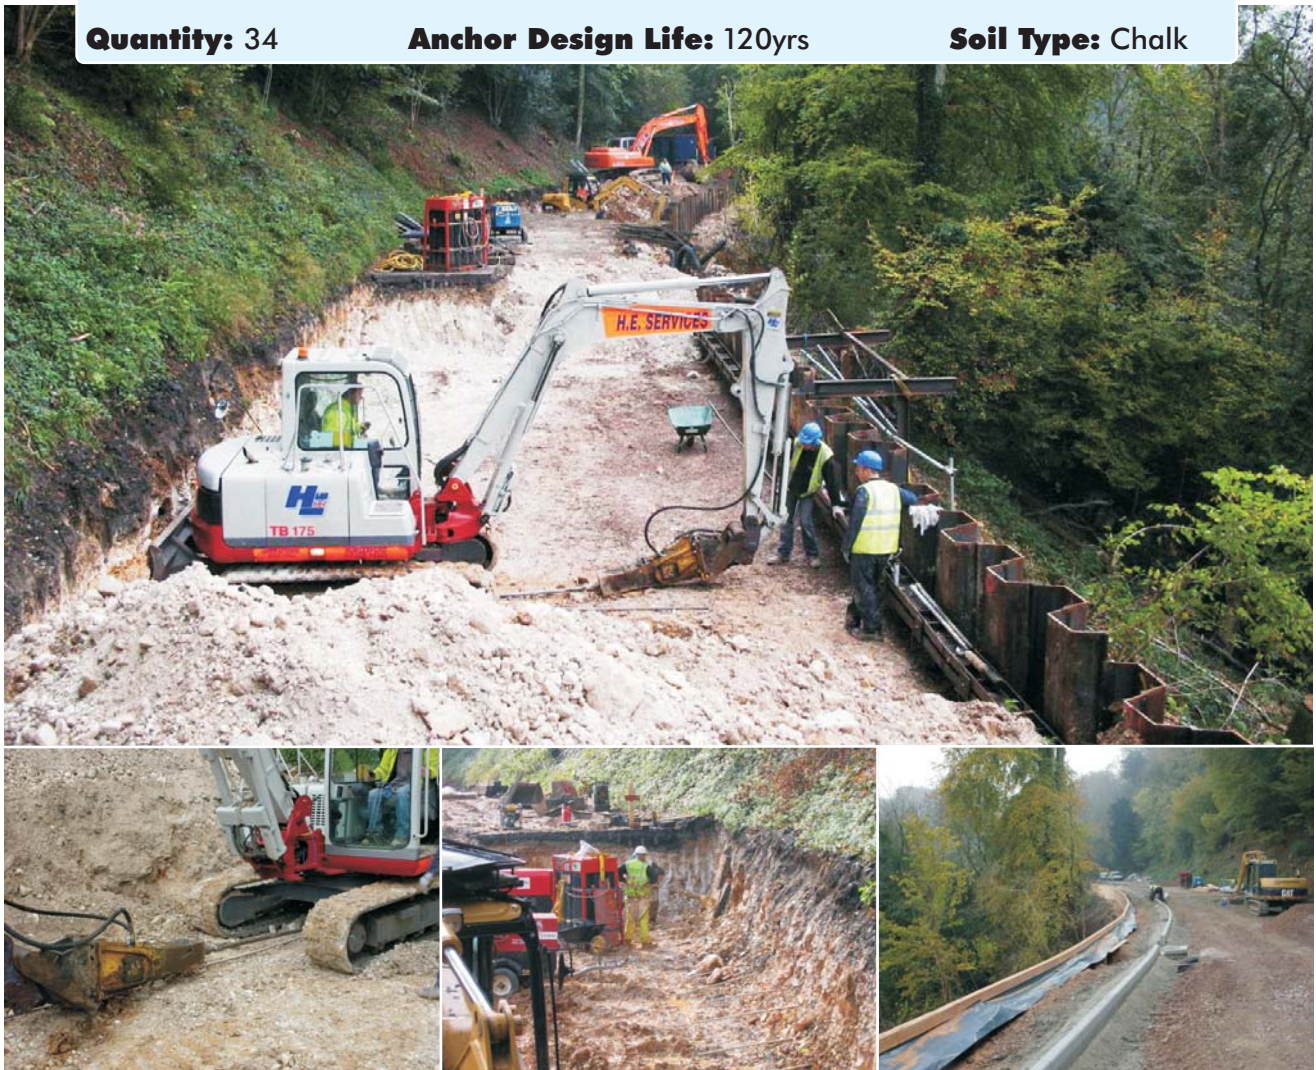
B08 bronze anchors fitted with stainless steel threaded bar were chosen following extensive site tests. These were installed horizontally across the line of the excavated carriageway into the chalk of the hillside. Once the anchors were loadlocked, the stainless steel bars were extended to reach the sheet pile wall and attached using stainless steel loadplates and loadnuts.

Anchor System: B08TB aluminium bronze anchor c/w 13m of 24mm Ø stainless steel threaded bar, 200mm x 200mm stainless steel load plate and loadnut.
