Case Study

OUTFALL PIPELINE - ISLE OF LEWIS

Client: Scottish Water

Contractor & Anchor Installer: Bardon Hebrides Ltd - Aggregate Industries UK Ltd

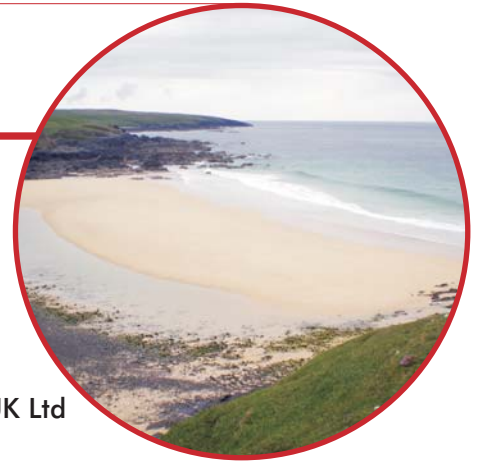
Due to localised shallow slip failures and ground movement along this stretch of the coastline the existing outfall pipeline has in places fractured and broken causing leakage of the pipe contents. This leakage into the surrounding ground has promoted further erosion and movement and increased the damage to the pipe and the surrounding area.

Complete replacement of this 700m long section of pipeline using a 280mm diameter HPPE product was deemed the most cost effective long term solution. To prevent the same fate affecting this new pipeline it was securely anchored into the bottom of a new trench at a depth below any future expected slope failure. Working with limited access the anchors provided a quick and easy way of securing the pipeline. The solution removed the requirement for concrete anchor blocks and minimised the need for machine traffic on site, reducing the damage to the surrounding machair grassland. Once the trench was backfilled S2Geo System anchors were used to secure a MacMatR geosynthetic to minimise any surface erosion and also help quickly regenerate the vegetation growth.

Anchor System: Pipeline - S06EB aluminium bronze anchor c/w 2m of 6mm Ø stainless steel wire tendon, 25mm wide polypropylene webbing strap and stainless steel ratchet fixing.
Erosion Control - S2 Geo System c/w 0.6m of 3mm Ø stainless steel wire tendon, 90mm Ø polyethylene plate & aluminium swage.
